# DETECTION AND LOCATING LEAKS IN UNDERGROUND WATER MAINS USING THERMOGRAPHY

Dr.E.N.Ganesh  
Professor, Department of ECE  
Saveetha Engineering College, Chennai

**Keywords**— Water pipelines; Thermography; Water Leak detection; Failure investigations

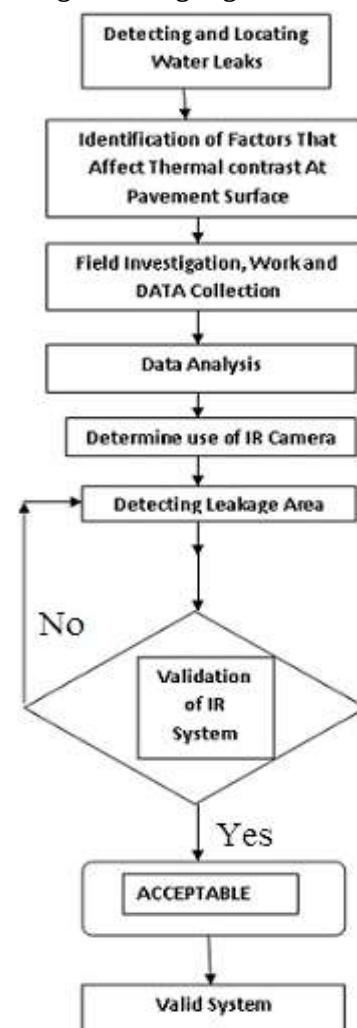
Figure 1: Proposed Methodology

The methodology presented in this study is based on intensive literature review, meeting with experts, and on the analysis of actual data collected from web site. The development of the methodology involves five major steps: I) identification of factors that affect thermal contrast at pavement surface; II) field investigation and on site experimental work; III) analysis of the data obtained in order to determine the most suitable conditions of using IR camera for the detecting and locating water leaks, IV) establish the relationship between the detected leakage area at pavement surface and the location of leak in the water main being tested; V) validation of the proposed methodology by comparing leak locations detected by the proposed system and by acoustic-based methods. Figure 1 shows the proposed methodology.

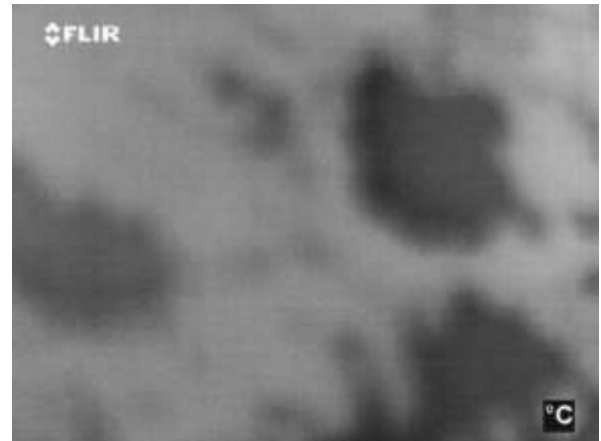
Figure 2: Thermal Contrast at Pavement Surface due to Water Leak

Figures 3 shows the relationship found between pipe temperature, average ambient air temperature and average pavement temperature in fall season. As shown in Figures 2 the warmer pipe temperature indicates high possibility in detecting water leaks using IR camera according to Equation 1 (ASHRAE 1981; Hutcheon and Handegord 1983; Bentz 2000)

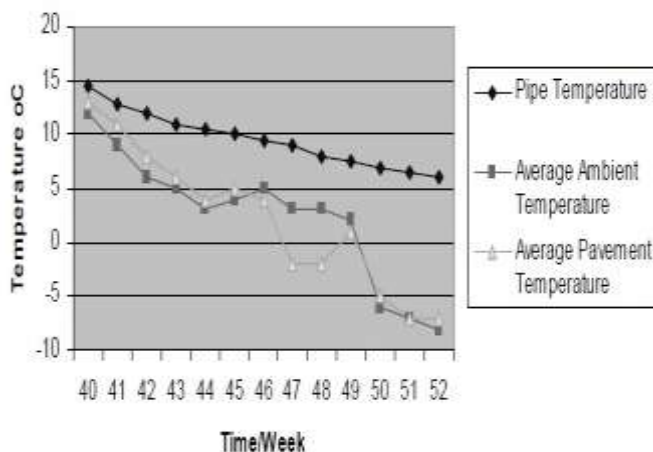
. Figure 3: Comparison between Temperatures in a Season

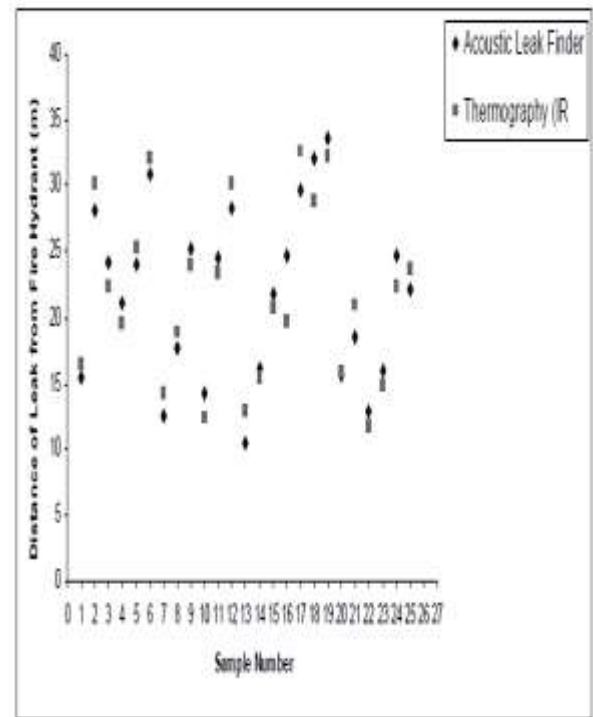
Figure 4: Leak Locations (m) using Acoustic Leak Finder Verses IR camera

The leak locations detected using IR camera for twenty five water leaks were compared to those detected using the acoustic-based leak finder method. The results are shown in Figure 4. As shown in Figure 4 the difference ranged from 1.01m to 2.30m

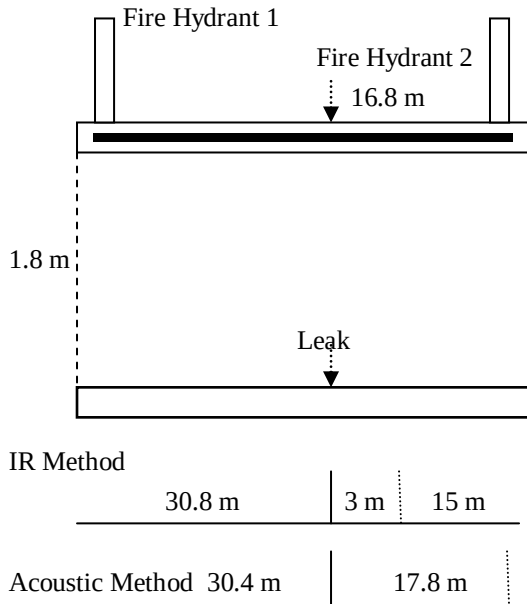
1- image number 6 showed thermal change as shown in Figure 5

The results obtained is shown in Figure 5

$$X = \frac{(N-1)0.28S}{R} = \frac{(6-1) \times 0.28 \times 6}{0.5} = 16.8 \text{ meter} \quad (3)$$
