INTERNATIONAL JOURNAL
OF ENGINEERING APPLIED SCIENCE
AND TECHNOLOGY

VOLUME : 7 ISSUE : 05 Print / Issue Publication Date: 06-Nov-2022

SHAPING AND EVALUATION OF PHYSICAL PARAMETERS FOR FARWA LAGOON - LIBYA

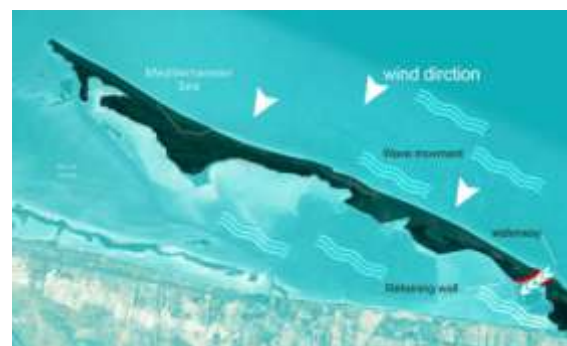
Fig. 3. Showing the wind direction and wav motion out and inside the lagoon

It concerns that the depth of the water related to the low recharging from the open sea. The picture on the side indicates

to this issue as it is clear that the wave motion and the wind direction hit the area from the northeast which handle the reformation of the island shape over the time. Moreover, the opening on the east side of the island is about 75 m long and 23 m wide, with a 0.5 m depth as clear in Images 4 a, b

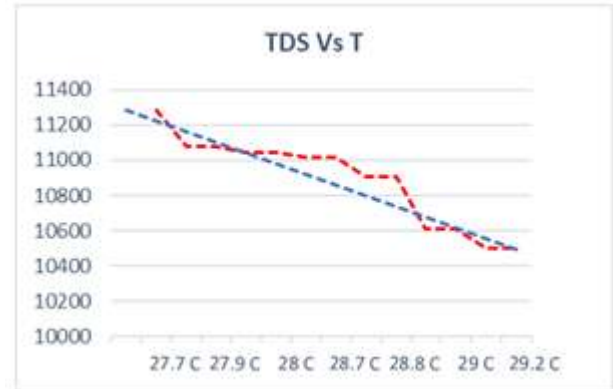
The total dissolved solids (TDS) in the Farwa lagoon are influenced by temperature and the conductivity of ions in water depends on the temperature of the water. Ions move faster when the water is warm.

Fig. 5. TDS (ppm) vs T (Co) for seven different locations at the site of study

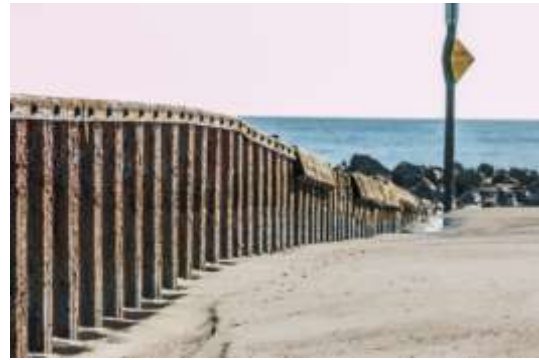
- Build retaining walls around the edge where the trench has been made. The retaining walls should be made with an engineering design to provide stability and a longer lifetime.

Fig. 8. showing Steel and concrete retaining wall as an example
