ADVANCED APPROACH IN SOLAR PV PLANT PROTECTION SYSTEM

V Venkatesh¹, D Vamsi Krishna², KV Kalyani³, Ashutosh Saxena⁴
Centre for Mining, Environment, Plant Engineering and Operations (CME)
National Council for Cement and Building Materials, Hyderabad, INDIA

Abstract: Solar Photovoltaic (PV) technology has become one of the most promising and reliable source of renewable energy. The favorable conditions like decreasing prices of PV system, increased panel size and enhanced efficiency improved the solar PV power plants installations. PV Panel and Inverter are vital equipment's in functioning of solar PV system. As the solar power plant has various power electronics and other electrical components, there might be chance for power interruptions due to improper functioning of switch gear. Ensuring protection measures of the solar power plant plays a key role in smooth functioning of the system. The main objective of the paper is to explain various protection issues faced in solar roof top system and the necessary measures taken for resolving the issues with root cause analysis. This technical paper also showcases various preventive maintenance activities followed in the solar PV plant.

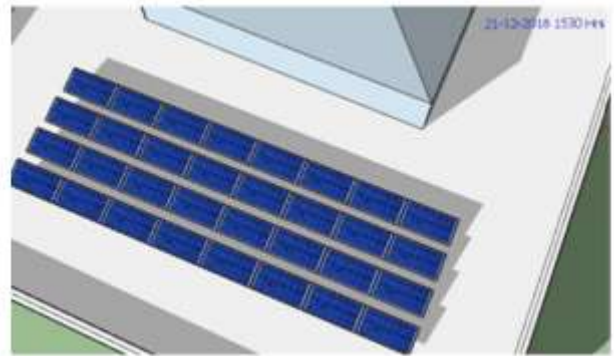
Figure 1: Shadow Analysis of rooftop

mounting solar PV panels. NCB-H has identified three buildings for installation of plant, among which administrative building is selected after performing shadow analysis. Shadow analysis is done to analyze the day light conditions at different time periods on a day at preferred location of the rooftop of NCB-H administrative building. Solar PV plant is designed in such a way that the modules are connected in strings to produce DC power output. Two strings are i.e. 16 No's of PV modules for each string making a total of 32 No of PV modules for two strings which are connected in parallel to the inverter. Inverter is provided with anti-islanding protection where inverter senses the power interruptions from the supply grid and shut itself to stop feeding power back to the grid. Protective devices for different DC and AC supplies are installed in inverter viz. DC reverse polarity protection, DC switch for MPPT, output AC over current protection, Output AC overvoltage protection, ground fault monitoring, grid monitoring and sensitive leakage current monitoring unit.

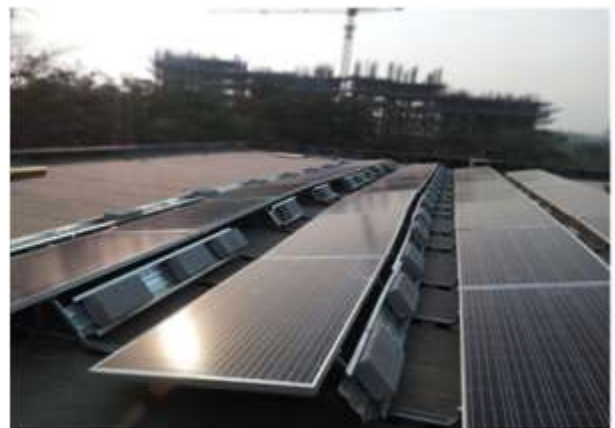
Figure 2: Solar PV Plant on rooftop of NCB-H

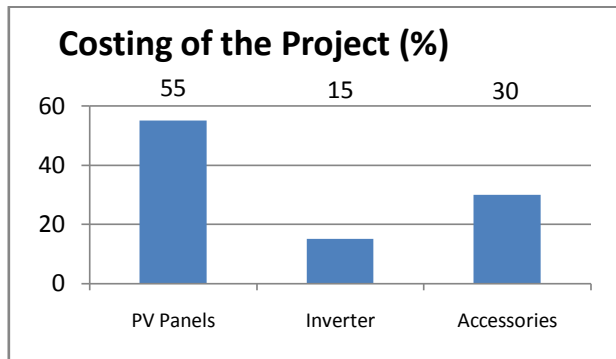
The percentage costing of components out of the total project cost is shown below.

Figure 3: Costing of the solar (PV) plant

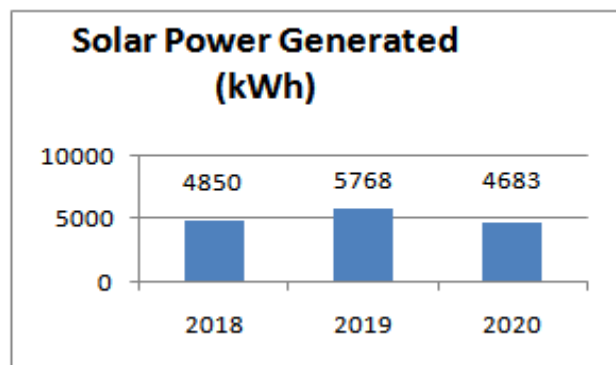
Figure 4: Solar PV plant generation trend

The energy generated till December 2020 is 15301 units. The savings realized from the generation of solar PV plant is around 1.4 Lakhs.

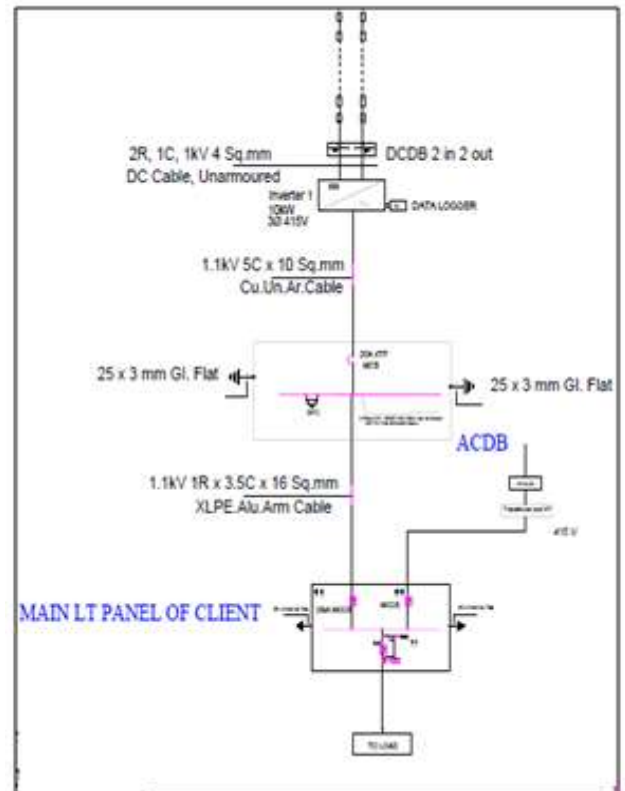
Figure 5: Single Line Diagram of Solar PV Plant

The Solar PV Plant comprises of PV Array, DC Distribution Board, Inverter and AC Distribution Board with a reference voltage from the existing panel. The solar power plant has various power electronics and other electrical components, there might be chance for power interruptions due to improper functioning of switch gear. The power flow from array to the existing electrical panel has been shown in the below single line diagram:

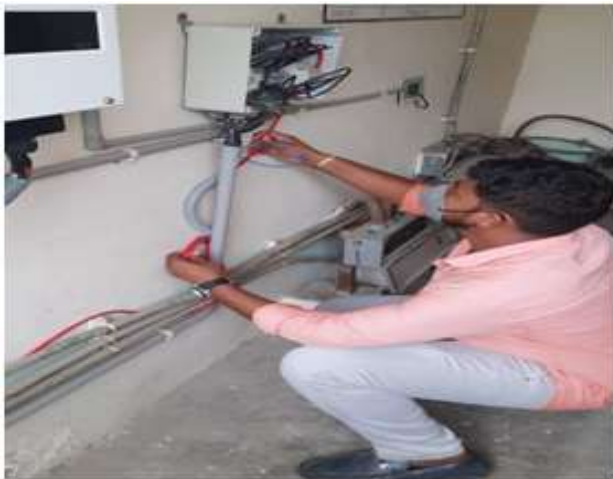
3.2 Inverter faults: It is observed that inverter is showing Error-117 on the display of inverter which indicates that there is a fault in the relay circuit in the inverter.

Root cause analysis: The healthiness of SPD in AC & DC Distribution Board, miniature circuit breaker of existing panel has been verified and found that AC Distribution board SPD burnt off. The other solar PV plant components like DC and AC cables have been thoroughly inspected and observed that there is no damage in the insulation. The SPD has been replaced with new SPD but inverter is showing the same fault code.

Figure 6: Technician providing dedicated DC Earthing

The inverter manual has been studied in detailed for additional technical information and manual suggests to have separate earthing for AC and DC system. The earthing of the AC & DC system of solar PV plant has been studied in detail and found that earthing has been made common for AC & DC. The international standard (**IEC 60364 Part 7-712**) for Low voltage installations, requirements for special installations or locations – solar photovoltaic (PV) power supply systems also suggesting to have separate earthing system for AC and DC system in Solar PV plant. Based on the above technical deliberations and discussions with inverter manufacturer, earthing of AC and DC has been separated. The inverter became functional after replacement of relay component which might got damaged due to infusion of fault current because of combined AC & DC earthing.

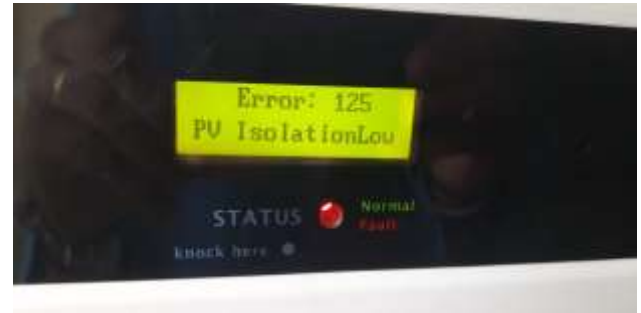
1.3 PV Isolation low: It is observed that inverter is showing Error-125 on the display of inverter which indicates that the inverter has detected a problem with the insulation of the system.

Root cause analysis: In humid weather conditions, it is often noticed that the occurrence of Error-125. The moisture ingress in the cable causes the DC current of the solar panel to leak to the earth on the array frame. The inverter senses the fault and shuts the system for its safety. Once the moisture is evaporated with rise in temperature from the sun the error extinguishes itself and the system starts to work again.

Figure 7: Error: 125 display on the inverter screen

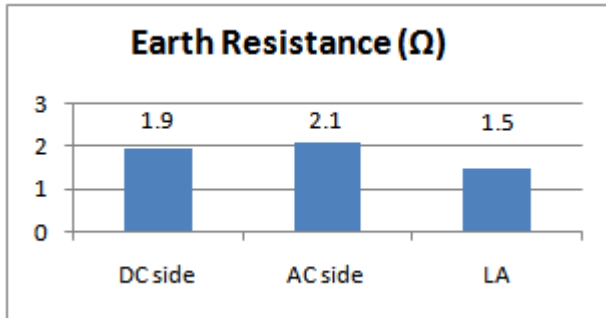
Figure 8:Earth pit resistance values of DC, AC and LA

Regular checking of earth pits is the best preventive maintenance activity performed in any electrical system. The earth resistance is measured with the help of Digital Earth resistance tester for DC, AC and LA at regular intervals. The measured Earth pit resistance values of DC, AC and LA are shown in graph below:
