# CORROSION BEHAVIOR STUDY OF STEEL POLE IN DIFFERENT COATING TECHNOLOGY

**Abstract**—Corrosion of steel pole is a serious issue as they used steel pole to support overhead power line in distribution. A lot of money and time are spent for maintenance and repair of existing steel pole. This paper presents investigation on various coating technologies of steel pole for initial corrosion activity. Five types of coating were used on steel samples; epoxy, VEF polyglass, galvanized, epoxy galvanized and polyglass galvanized. The accelerated ageing test, salt spray test and water absorption test were used to determine coating degradation and severity of corrosion process. It was found that, the corrosion rate for epoxy galvanized and VEF polyglass galvanized were higher as the samples were undergoing accelerated ageing test. While VEF polyglass steel showed higher percentage of weight loss during salt spray test. In addition, the results of water absorption behavior showed that epoxy steel gave higher average of absorption rate. The results obtained lead to low degradation of coating as the corrosion rate seem to be uniform

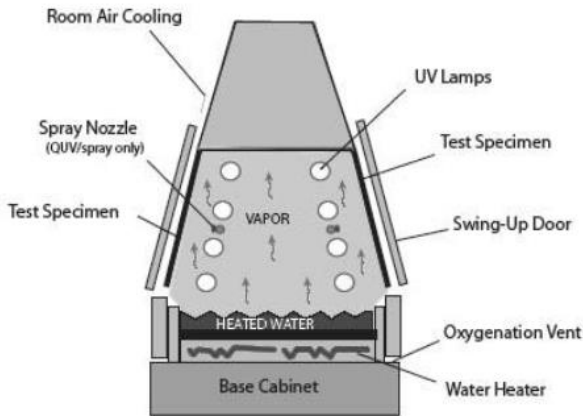
Fig. 2. QUV Accelerated Weathering chamber [17]

The accelerated aging test consists of the following cycle, in the beginning the samples are exposed to 8 hours at 60 °C ( $\pm 2.5$  °C) to ultraviolet (UV) radiation in a modified commercial QUV Accelerated Weathering Tester as show in Fig 2 [17]. For solar reflectors the lamp type UVA-340 is used. The lamps emit radiation in short wavelength-range of 295 to 365 nm with peak emission is at 340 nm. The radiation of UV emitted by UVA-340 lamps are almost same to natural sunlight as the spectral power distribution (SPD) of UVA-340 is very close to sunlight (see Fig 3). After that, the samples are

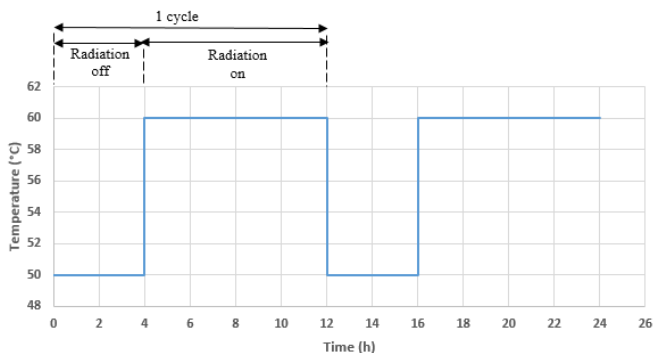
Fig. 4. Accelerated aging testing cycle

exposed to 4 hours at 50 °C ( $\pm 2.5$  °C) to condensation (100% relative humidity with 1.55 W/m<sup>2</sup>/nm irradiation) [18]. The total duration of one cycle is 12 hours (see Fig 4). Thus, in this work the samples are exposed to control environment based on American Society of Testing and Materials (ASTM) D5894-96 and ASTM D4587 as shown in Table 3. The testing is run for 1,968 hours.

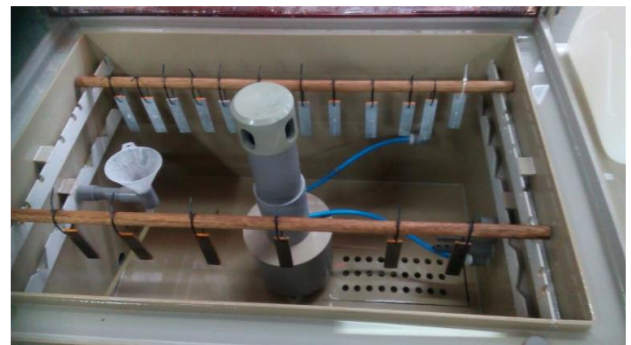
Fig. 5. Salt spray test

The samples are tested according to ASTM B117 and this standard is widely used for salt spray testing. The samples are placed in enclosed chamber and exposed to continuous indirect of salt water solution at rate 1.0 to 2.0 ml/h on a surface of 80 cm<sup>2</sup> [19]. The chamber condition is set to 35 °C with a spray of sodium chloride (NaCl) solution by ratio of 5% sodium chloride and 95% of pure water, by weight. The pH of the salt solution is maintained at 6.5 to 7.2 which is used in NSS test (Neutral Salt Spray). The chamber climate is maintained under constant steady state condition and the test duration is variable, as show in table 4.

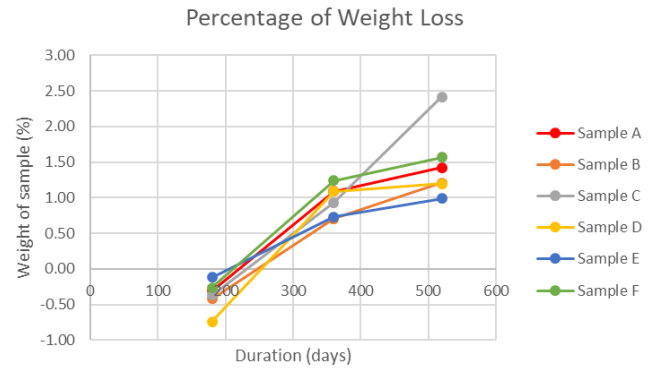
Fig. 7. Percentage of weight loss for 180, 360 and 520 days

From the results, at 180 days the weight loss of tested samples was gaining weight as the chloride from salt spray was accumulated on the samples. Thus, it shows a negative value to

percentage loss, as show in table 7.1. This indicate that the samples are gain of weight. Then, for next cycle at 360 days, the samples have a weight loss in between 0.7 % to 1.2 %. At this stage, acceleration of chemical reaction process was occurred due to presence of salt which acted as a catalyst to accelerate the corrosion process. From the table 7.2, sample F show the highest weight loss, 1.24 % in this process while sample B show the lowest weight loss, which gave to 0.70 % reduction of weight. As the duration was increased to 540 days, the layer of coating of samples tested were started to peel off. This process was indicated that more mass of the substrate element of the samples have fallen off due to weight loss up to 2.4 %.

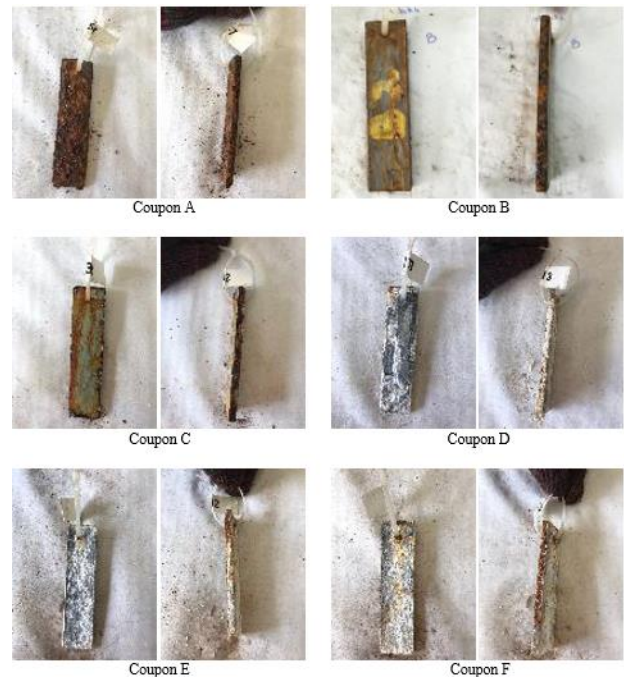
Fig. 8. Condition of each sample after undergo in salt spray chamber after 180 days

The salt spray test is used to evaluate corrosion process and coating degradation of each samples. The samples are tested in more realistic method by placed them in a controlled corrosive environment to produce relative corrosion information for each samples. The visual observation of corroded samples after 180 days in chamber is shown as Fig. 8. The effect of chloride was appeared on the six samples after the samples were tested for 180, 360 and 540 days. It can be seen that corrosion activity was aggressively occur at sample A as the color and physical condition of sample are changed. The sample A are heavily corroded as it is a bare steel. While for other samples, the rusting color is almost same as the corrosion activity seems to be uniform.

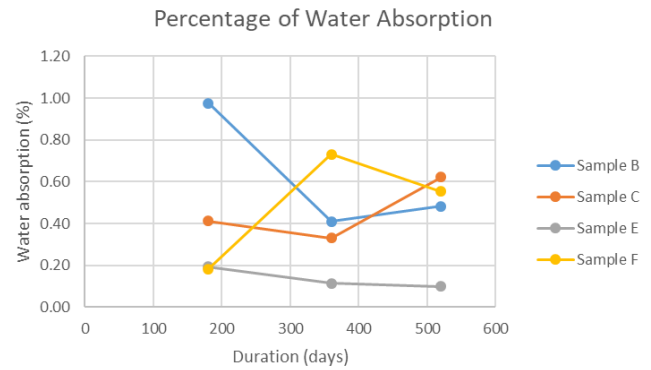
Fig. 9. Percentage of water absorption for 180, 360 and 520 days

For this test, only four types of samples are measured as the sample A and sample D are not coated with any coating technology. From the graph, epoxy coating technology shows consistence results for steel pole (sample B) and galvanised pole (sample E). The trends for both samples are uniform, as the water absorption are decreasing (0.97 % to 0.48 % and 0.19 % to 0.1 %) against exposure time (duration). Inversely for VEF polyglass coating technology, the trend are not consistence between sample C and sample F. The trend of water absorption are increasing with maximum of 0.62 % and 0.55 % for steel pole (sample C) and galvanised pole (sample F).
