ANTI-EROSION AND RIVER TRAINING WORKS ALONG THE BANKS OF RANGANADI RIVER, ASSAM

Suresh Maurya Central Soil and Materials Research Station, New Delhi, India Dr. Manish Gupta Central Soil and Materials Research Station, New Delhi, India

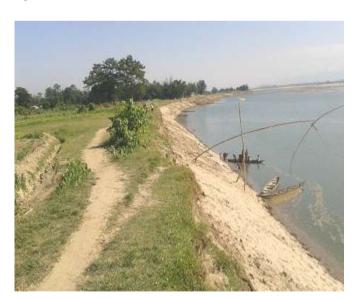
Fig. 3. Erosion of cultivable land

The River Ranganadi is an aggrading and meandering type of river by nature. Before entering the plains of Assam, numbers of big and small streams join to the River Ranganadi at the upper catchment area. Most of such streams carry large amount of silts/sand/tinny stone aggregates/boulders/gravel etc and deposit them at the bed of River Ranganadi. As a result, it creates sand chores in one bank and causing erosion at the other bank as shown in Fig. 3. Due to rapid growth of population and encroachment of forest land, the hills have become barren and landslide occurs very frequently during rainy season which in turn accelerates the deposition of silt load in these streams as well as in the bed of the River Ranganadi. This type of phenomenon has been continuously observed for the last two decades and is the main cause of rise of river bed. In addition to gradual rise of river bed, it is a matter of great concern that during every flood season, due to increase in the inflow of water from the upper catchment areas, the surplus/excess discharge have to be allowed to spill over the Ranganadi Dam of the NEEPCO hydel power project which ultimately increases the discharge at the downstream reaches. Figure 1 shows the location of Ranganadi Dam. Due to combined effect of increase in the river discharge along with gradual rise in the river bed, flood lift occurs in the River Ranganadi within a very short period and threatens both the banks embankment system. Every year the rise in flood lift decreases the free board and cause overtopping. Now, as per flood frequency analysis a DHFL has been calculated which has been found as 98.24 m at gauge site and it is 1.38 m above the observed HFL of 2008 (96.86 m). Now, for safety of the embankments against the anticipated flood lift, the embankment system at both the banks of River Ranganadi is required to be raised.

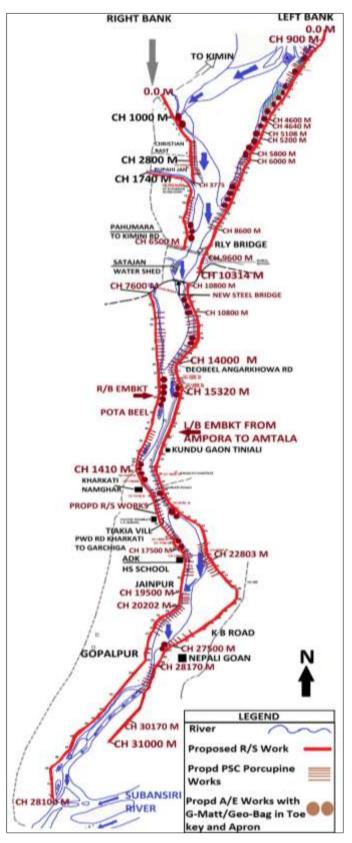
Fig. 4. Location of anti-erosion and river training work

Pre-stressed cement concrete (PSC) Porcupine works in the form of bars are also carried out at selected reach to provide additional protection to the banks by dampening the velocity of flow and inducing siltation in the vicinity of bank. Spacing of each porcupine bars are arranged 25 m clear distance with 3 rows of porcupine in each bar and 5 nos. of porcupines in each row all along the banks at required location. Erection of porcupine bars is done with six members pre-stressed cement concrete (M-40 grade reinforced with 4 nos. of 4 mm dia. high tensile steel wire cables at four corners and 4 mm high tensile stirrups at 250 mm c/c) of size 0.10 m \times 0.10 m \times 3.0 m properly fitting/fixing with 12 mm dia. 25 cm long M.S. nuts and bolts. Total quantity of porcupine deployed is 15372 nos. Figure 4 shows the location of PSC Porcupine bars in Left and right bank embankment at selected reach.

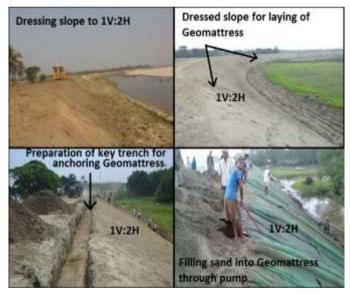
Fig. 5. Installation of Geotextile mattress at various stages

Bank revetment and launching of apron is being carried out for left and right bank embankment of Ranganadi River at various vulnerable reaches for a total length of 7200 m where the river bank is dressed to the inclination of 1V: 2H and over this a layer of geotextile tubular mattress of 0.3 m fill height is laid and anchored at the top and toe of bank slope by bending the mat into key trench of size 1.0 m x 0.75 m. Geotextile mattress is a double layered composite geotextile fabricated to form a three dimensional mattress after filling sand through pump at design slope of affected reach, the upper layer of the mattress is made from polypropylene woven geotextile needlepunched with a mixture of Ultraviolet (UV) stabilized green fibers and cut tape yarns and the lower layer of the mattress is also a UV stabilized polypropylene woven fabric. Total quantity of geo-mattresses under use is 1061939 m². Figure 5 shows installation of geotextile mattress at various stages.

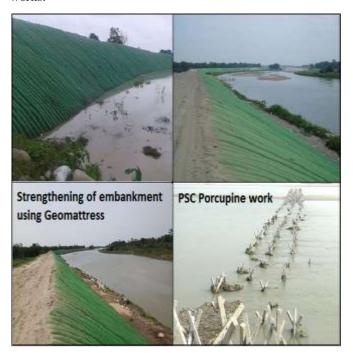
Fig. 7. Implementation of geotextile mattress and porcupine works

The paper presents the problems and the remedial works along the vulnerable reaches of River Ranganadi. The problem of flood and erosion in Assam is of high magnitude and to effectively deal with these issues, permanent solution will be essential in the near future. Such application replaces all other conventional methods (e.g. boulders, RCC etc.) for immediate protection where flood is a regular phenomenon and construction is to be completed in a limited time period. The use of geotextiles materials permits to carry out the protection works at a faster rate. The use of the mechanically twisted zinc coated wire mesh gabion box ensured the stability of the geotextile bags and provide confinement in toe-key. Figure 7 shows implementation of geotextile mattress and porcupine works.
